**Flood Control Project Maintenance  
Levee Inspections**  
**2009 Channel Summary Report**  
**Overall Unit and Item Ratings**

**DWR Sutter Maintenance Yard**

**Flood Control Project Maintenance****Unit Cover Sheet****2009 Channel Inspection Results****DWR Sutter Maintenance Yard**

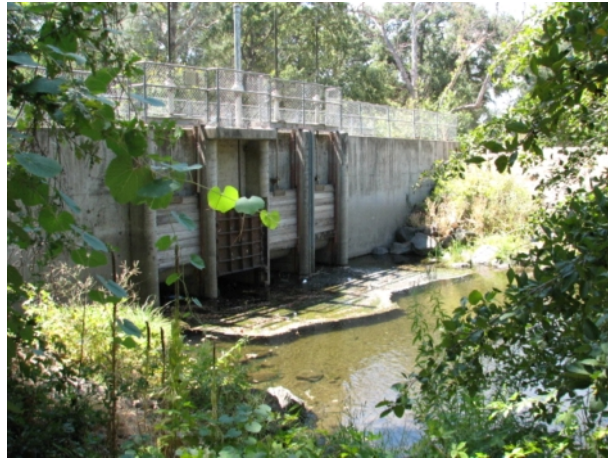
Levee Mile Report Line	1
Start Levee Mile	0.00
End Levee Mile	0.00
Location	
Category	Channels
Item	Vegetation & Obstructions
Big Chico Creek Control Structure.	
cathom_20090825_1.jpg

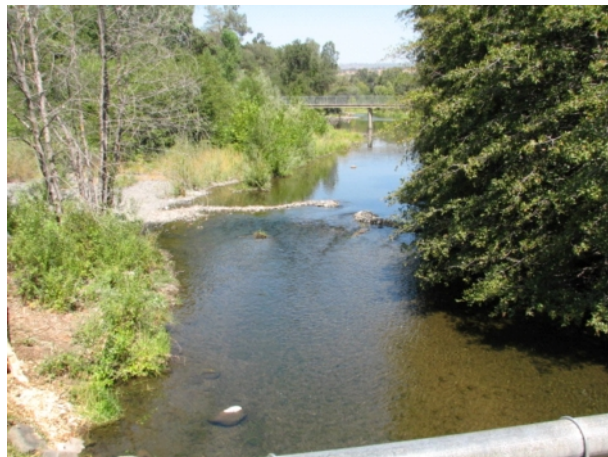
Levee Mile Report Line	1
Start Levee Mile	0.00
End Levee Mile	0.00
Location	
Category	Channels
Item	Vegetation & Obstructions
Up stream from Big Chico Creek Control Structure.	
cathom_20090825_2.jpg

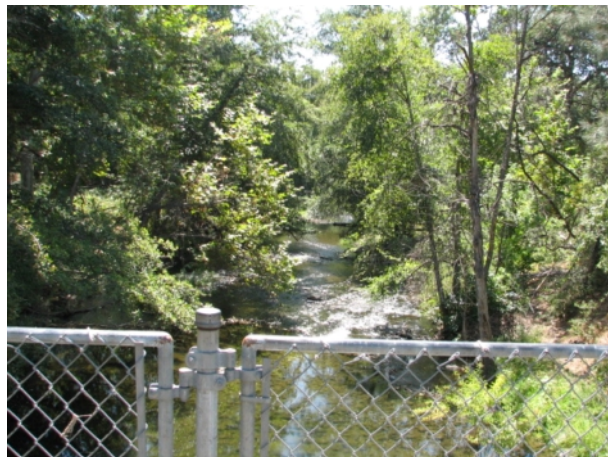
Levee Mile Report Line	6
Start Levee Mile	0.00
End Levee Mile	0.00
Location	
Category	Channels
Item	Vegetation & Obstructions
Downstream from Big Chico Creek Control Structure, growth along both banks.	
cathom_20090825_3.jpg

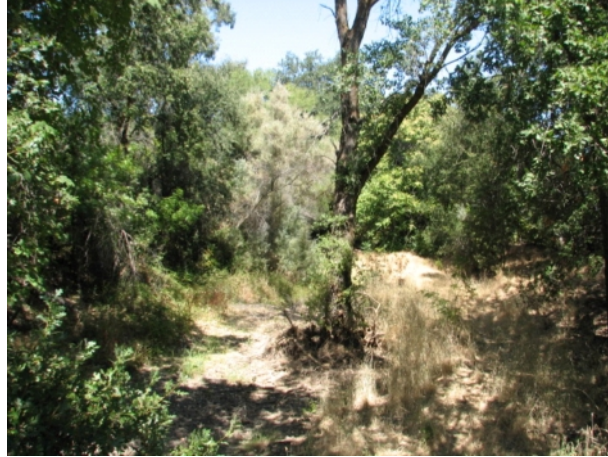
Levee Mile Report Line	11
Start Levee Mile	0.00
End Levee Mile	0.00
Location	
Category	Channels
Item	Vegetation & Obstructions
Up stream from the bridge near Forrest Avenue, growth along both banks.	
cathom_20090825_4.jpg

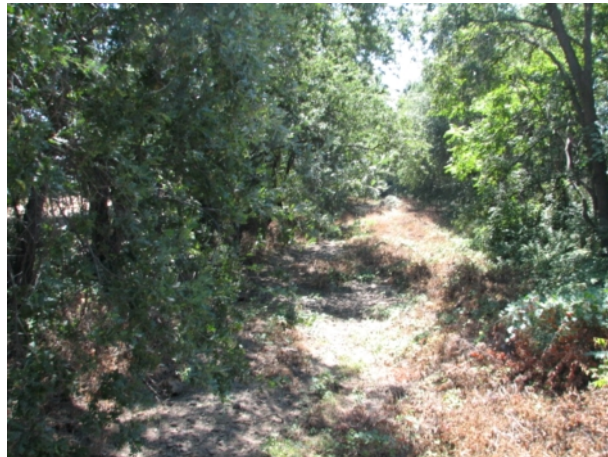
Levee Mile Report Line	16
Start Levee Mile	0.00
End Levee Mile	0.00
Location	
Category	Channels
Item	Vegetation & Obstructions
Down stream of Forrest Avenue, growth along both banks.	
cathom_20090825_5.jpg

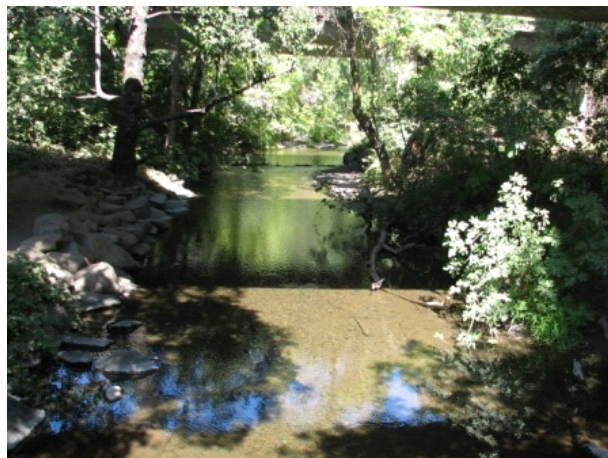
Levee Mile Report Line	21
Start Levee Mile	0.00
End Levee Mile	0.00
Location	
Category	Channels
Item	Vegetation & Obstructions
Up stream at Hwy 99 bridge, growth along both banks.	
cathom_20090825_6.jpg

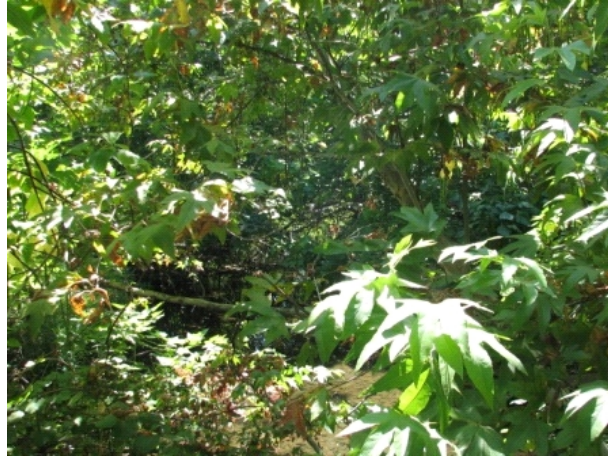
Levee Mile Report Line	26
Start Levee Mile	0.00
End Levee Mile	0.00
Location	
Category	Channels
Item	Vegetation & Obstructions
Down stream of Hwy 99 bridge, growth along both banks and over channel.	
cathom_20090825_7.jpg

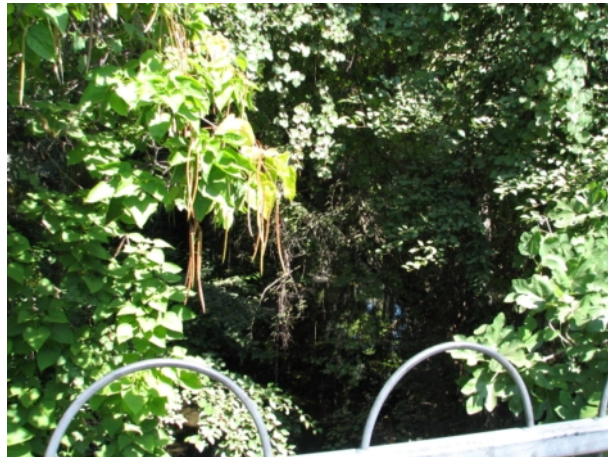
Levee Mile Report Line	31
Start Levee Mile	0.00
End Levee Mile	0.00
Location	
Category	Channels
Item	Vegetation & Obstructions
Up stream at Esplanade, heavy growth on both banks.	
cathom_20090825_10.jpg

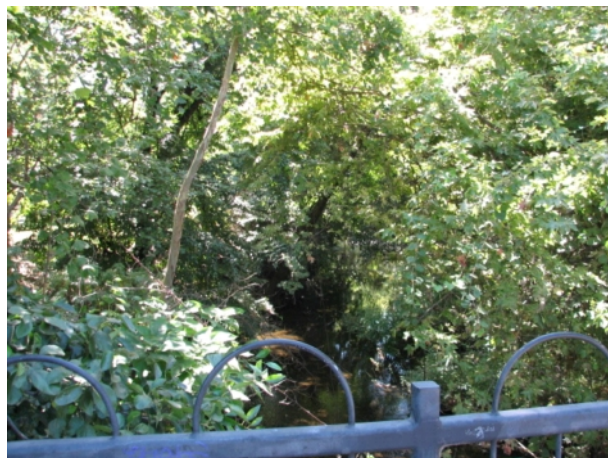
Levee Mile Report Line	36
Start Levee Mile	0.00
End Levee Mile	0.00
Location	
Category	Channels
Item	Vegetation & Obstructions
Down stream at Esplanade, heavy growth on both banks.	
cathom_20090825_9.jpg

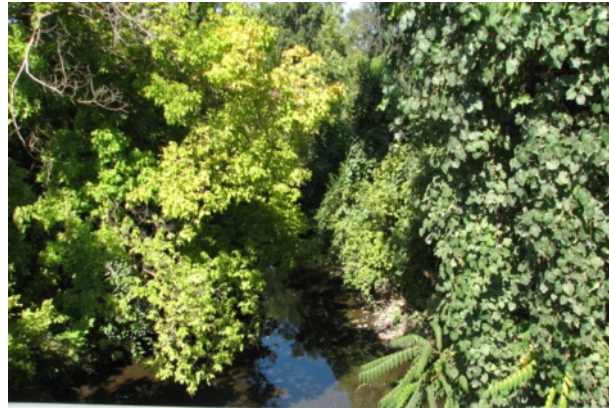
Levee Mile Report Line	41
Start Levee Mile	0.00
End Levee Mile	0.00
Location	
Category	Channels
Item	Vegetation & Obstructions
Up stream from Hwy 32, heavy growth on both banks.	
cathom_20090825_11.jpg

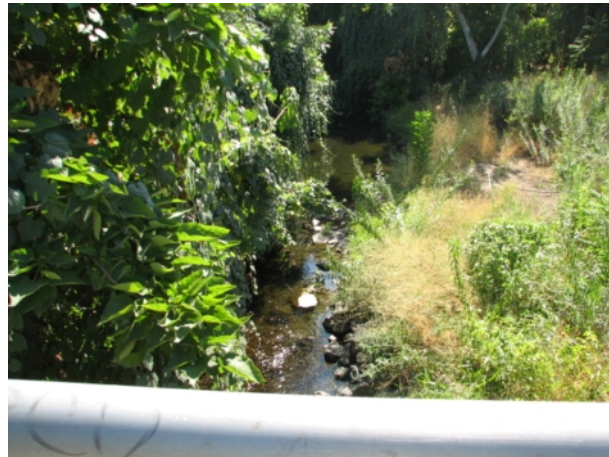
Levee Mile Report Line	46
Start Levee Mile	0.00
End Levee Mile	0.00
Location	
Category	Channels
Item	Vegetation & Obstructions
Down stream from Hwy 32, vegetation and over growth in the channel.	
cathom_20090825_12.jpg

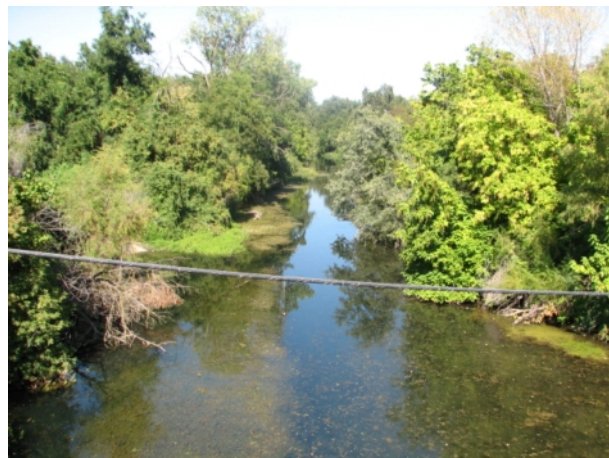
Levee Mile Report Line	51
Start Levee Mile	0.00
End Levee Mile	0.00
Location	
Category	Channels
Item	Vegetation & Obstructions
Up stream Mud Creek, heavy growth on both banks.	
cathom_20090825_13.jpg

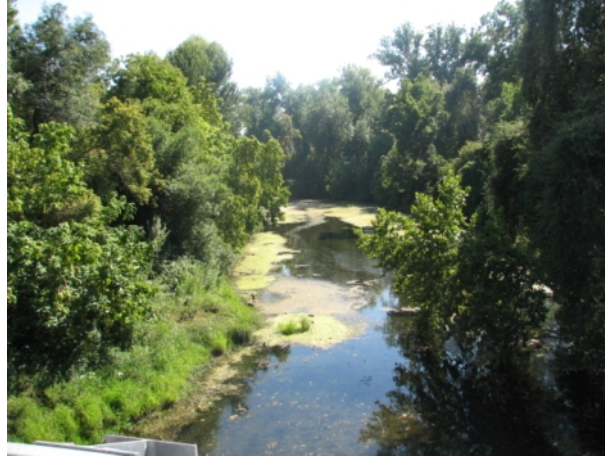
Levee Mile Report Line	56
Start Levee Mile	0.00
End Levee Mile	0.00
Location	
Category	Channels
Item	Vegetation & Obstructions
Down stream Mud Creek, heavy growth on both banks.	
cathom_20090825_14.jpg

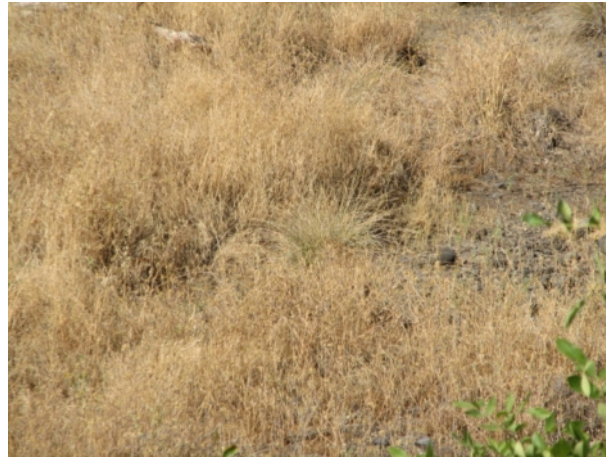
Levee Mile Report Line	6
Start Levee Mile	0.00
End Levee Mile	0.00
Location	
Category	Channels
Item	Vegetation & Obstructions
Down stream of the diversion structure.	
cathom_20090903_18.jpg

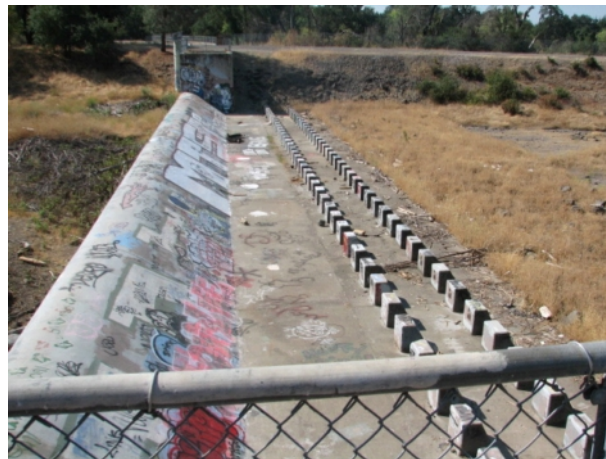
Levee Mile Report Line	7
Start Levee Mile	0.00
End Levee Mile	0.00
Location	
Category	Channels
Item	Shoaling / Sedimentation
The diversion structure.	
cathom_20090903_19.jpg

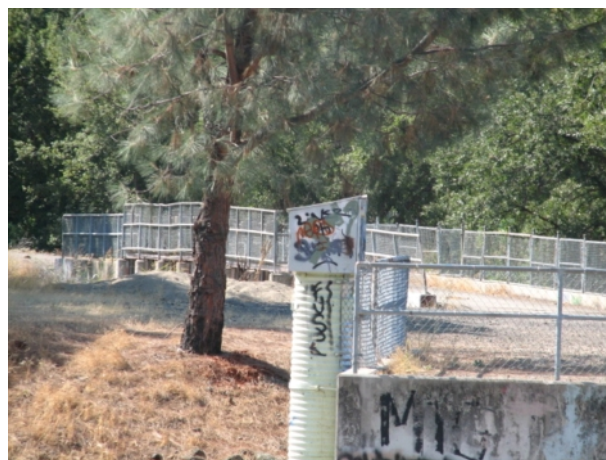
Levee Mile Report Line	7
Start Levee Mile	0.00
End Levee Mile	0.00
Location	
Category	Channels
Item	Shoaling / Sedimentation
The diversion structure.	
cathom_20090903_20.jpg

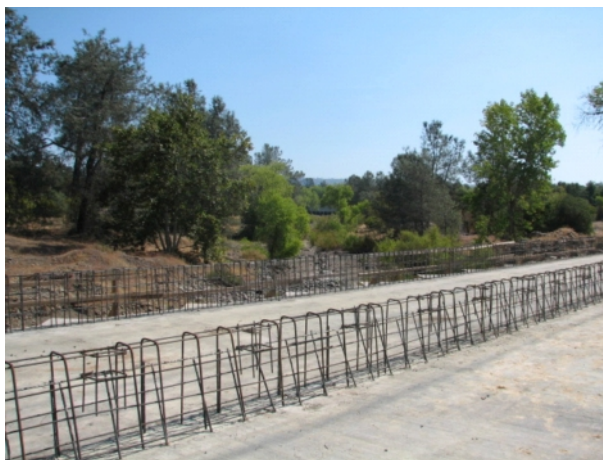
Levee Mile Report Line	11
Start Levee Mile	0.00
End Levee Mile	0.00
Location	
Category	Channels
Item	Vegetation & Obstructions
Up stream from Manzanita Avenue, construction work on the bridge.	
cathom_20090903_21.jpg

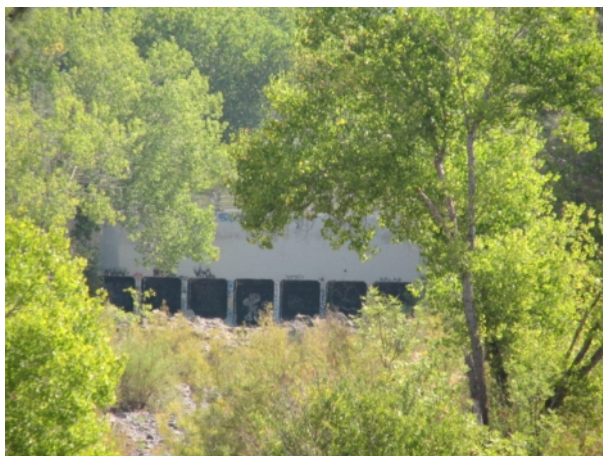
Levee Mile Report Line	11
Start Levee Mile	0.00
End Levee Mile	0.00
Location	
Category	Channels
Item	Vegetation & Obstructions
Structure up stream from Manzanita Avenue bridge.	
cathom_20090903_22.jpg

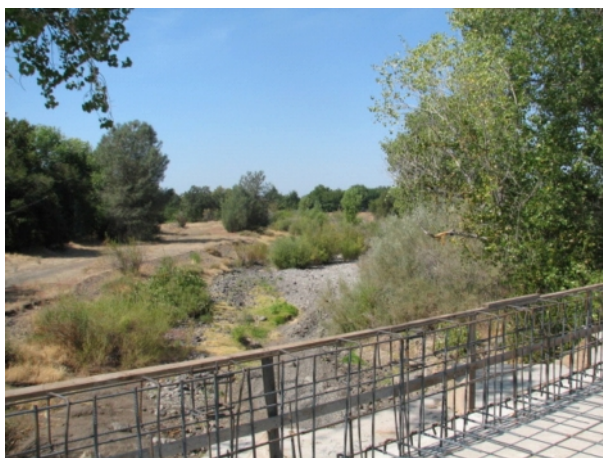
Levee Mile Report Line	16
Start Levee Mile	0.00
End Levee Mile	0.00
Location	
Category	Channels
Item	Vegetation & Obstructions
Down stream of Manzanita Avenue.	
cathom_20090903_23.jpg

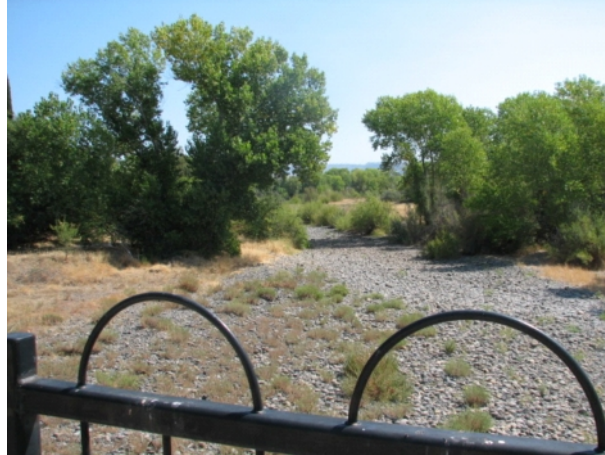
Levee Mile Report Line	21
Start Levee Mile	0.00
End Levee Mile	0.00
Location	
Category	Channels
Item	Vegetation & Obstructions
Up stream from the bike path bridge at the extension of Madrone Avenue.	
cathom_20090903_24.jpg

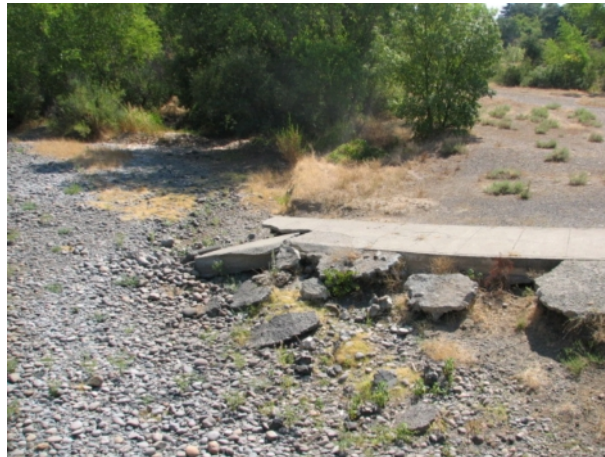
Levee Mile Report Line	23
Start Levee Mile	0.00
End Levee Mile	0.00
Location	
Category	Channels
Item	Erosion / Bank Caving
Up stream access ramp is damaged.	
cathom_20090903_26.jpg

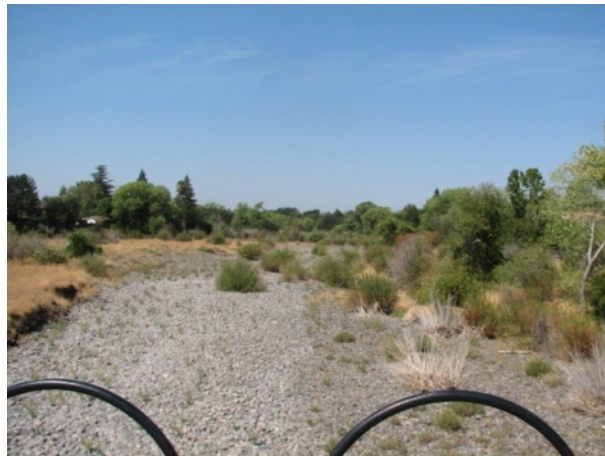
Levee Mile Report Line	26
Start Levee Mile	0.00
End Levee Mile	0.00
Location	
Category	Channels
Item	Vegetation & Obstructions
Down stream from the bike path at the extension of Madrone Avenue.	
cathom_20090903_25.jpg

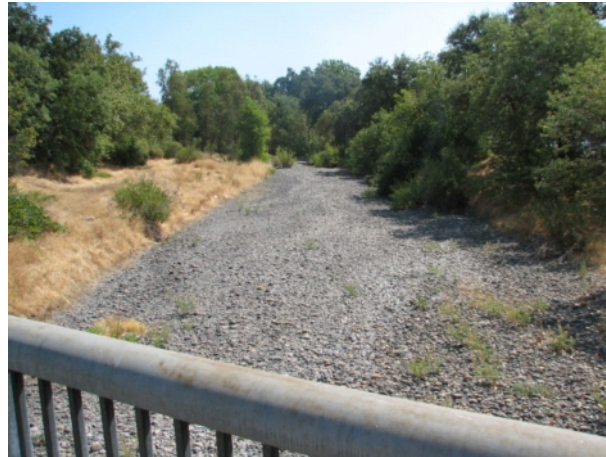
Levee Mile Report Line	31
Start Levee Mile	0.00
End Levee Mile	0.00
Location	
Category	Channels
Item	Vegetation & Obstructions
Up stream from Mariposa.	
cathom_20090903_27.jpg

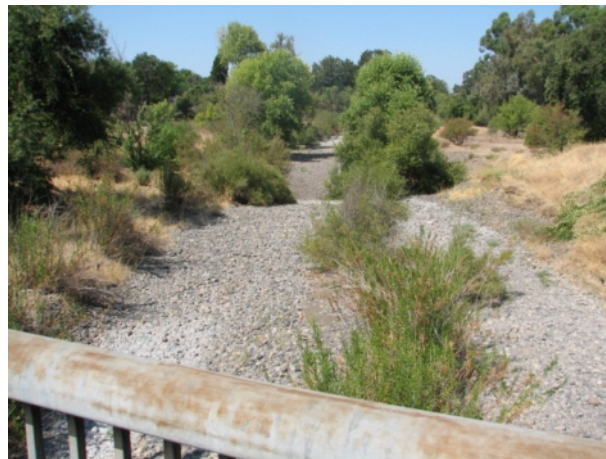
Levee Mile Report Line	36
Start Levee Mile	0.00
End Levee Mile	0.00
Location	
Category	Channels
Item	Vegetation & Obstructions
Down stream of Mariposa.	
cathom_20090903_28.jpg

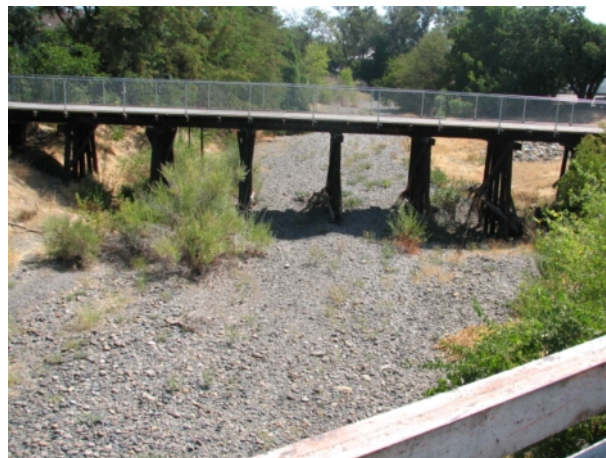
Levee Mile Report Line	51
Start Levee Mile	0.00
End Levee Mile	0.00
Location	
Category	Channels
Item	Vegetation & Obstructions
Up stream from Esplanade.	
cathom_20090903_29.jpg

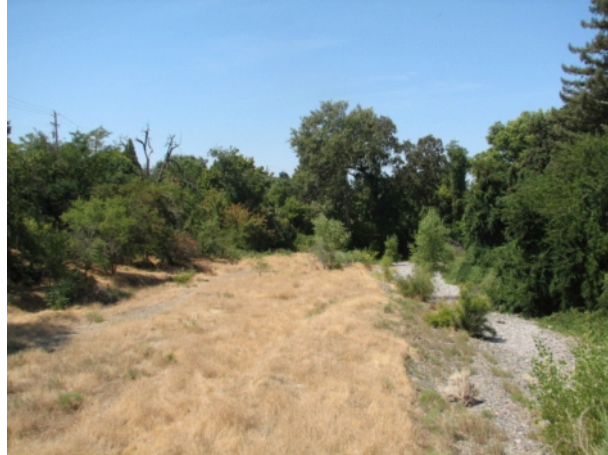
Levee Mile Report Line	56
Start Levee Mile	0.00
End Levee Mile	0.00
Location	
Category	Channels
Item	Vegetation & Obstructions
Down stream from Esplanade.	
cathom_20090903_30.jpg

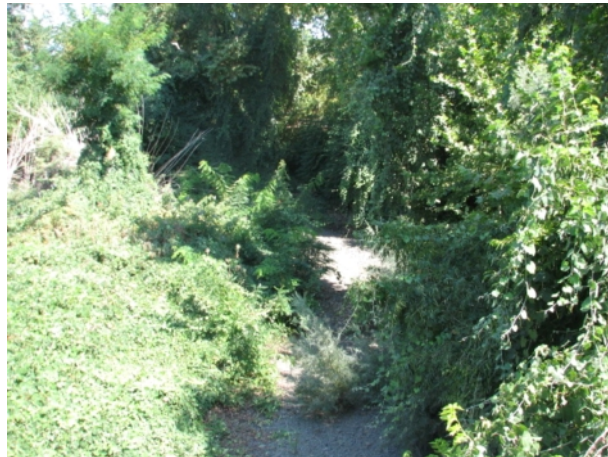
Levee Mile Report Line	61
Start Levee Mile	0.00
End Levee Mile	0.00
Location	
Category	Channels
Item	Vegetation & Obstructions
Up stream from Highway 32, vegetation in the channel.	
cathom_20090903_31.jpg

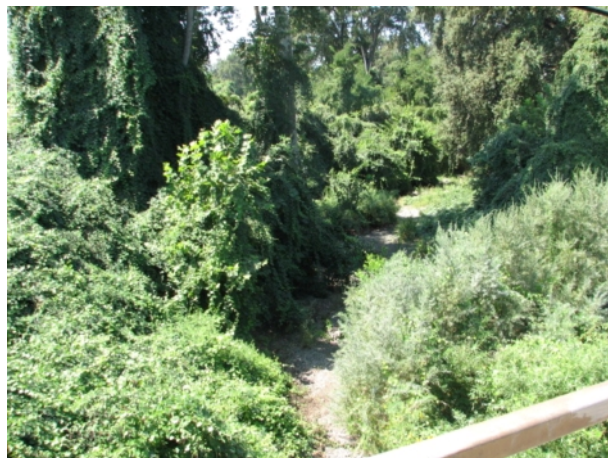
Levee Mile Report Line	66
Start Levee Mile	0.00
End Levee Mile	0.00
Location	
Category	Channels
Item	Vegetation & Obstructions
Down stream from Highway 32, vegetation in the channel.	
cathom_20090903_32.jpg

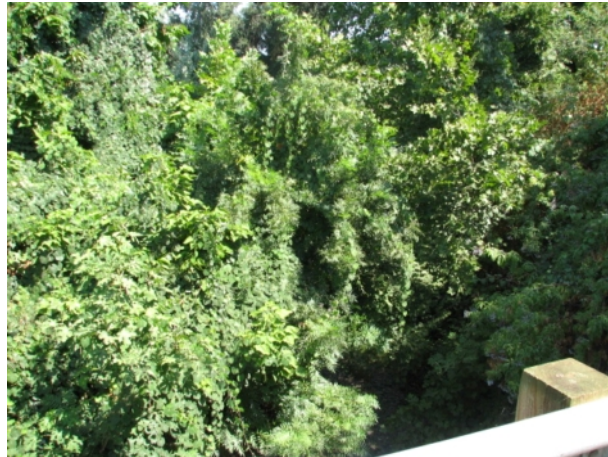
Levee Mile Report Line	71
Start Levee Mile	0.00
End Levee Mile	0.00
Location	
Category	Channels
Item	Vegetation & Obstructions
Up stream from Oak Avenue, vegetation in the channel.	
cathom_20090903_33.jpg

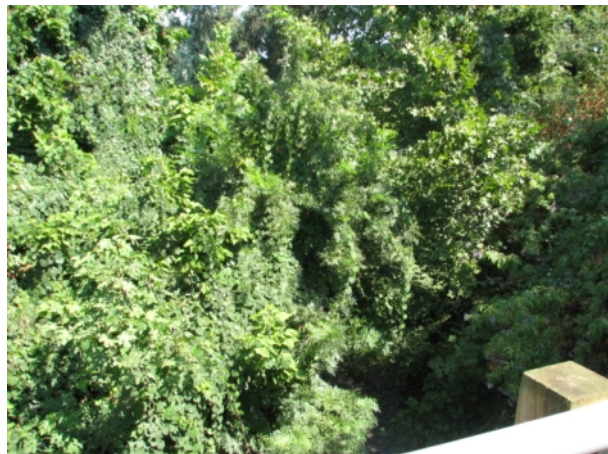
Levee Mile Report Line	72
Start Levee Mile	0.00
End Levee Mile	0.00
Location	
Category	Channels
Item	Shoaling / Sedimentation
Up stream of Oak Avenue, vegetation in the channel obstructig the inspection.	
cathom_20090908_34.jpg

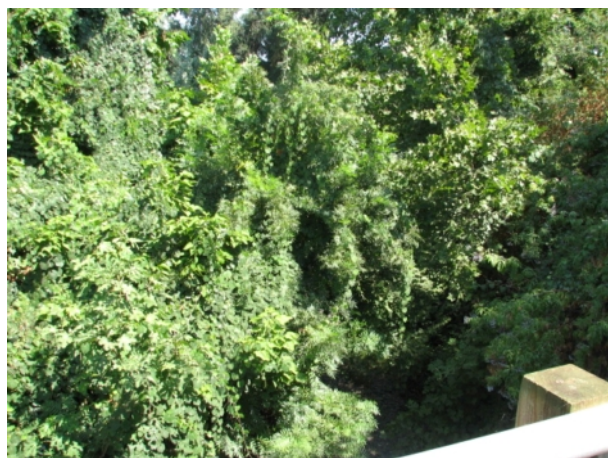
Levee Mile Report Line	73
Start Levee Mile	0.00
End Levee Mile	0.00
Location	
Category	Channels
Item	Erosion / Bank Caving
Dense vegetation in the channel obstructed the inspection.	
cathom_20090908_35.jpg

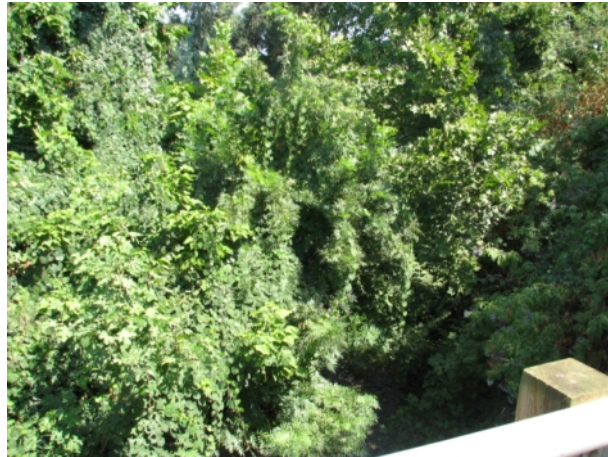
Levee Mile Report Line	74
Start Levee Mile	0.00
End Levee Mile	0.00
Location	
Category	Channels
Item	Revetments
Vegetation in the channel obstructed the inspection.	
cathom_20090908_36.jpg

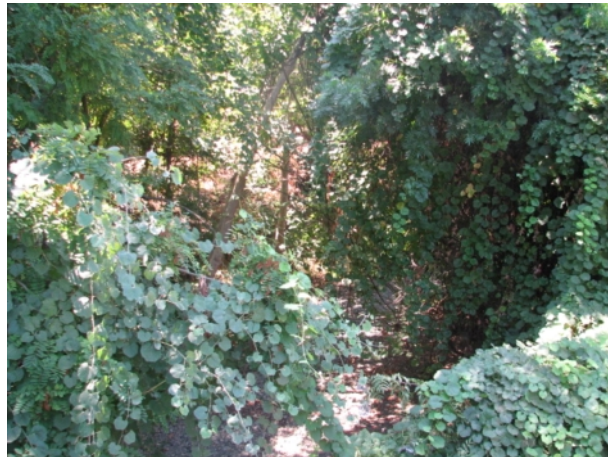
Levee Mile Report Line	76
Start Levee Mile	0.00
End Levee Mile	0.00
Location	
Category	Channels
Item	Vegetation & Obstructions
Down stream of Oak Avenue, vegetation in the channel.	
cathom_20090908_37.jpg

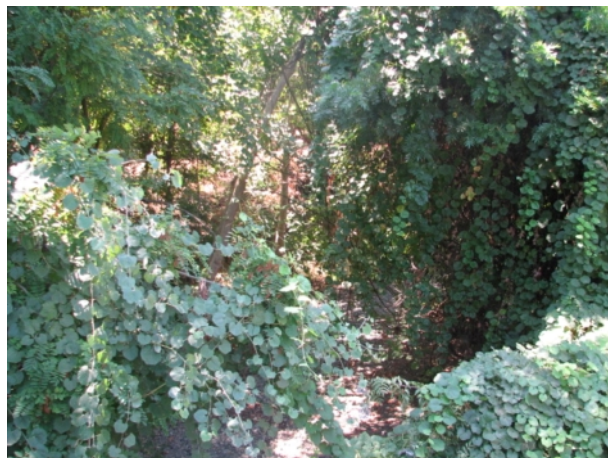
Levee Mile Report Line	77
Start Levee Mile	0.00
End Levee Mile	0.00
Location	
Category	Channels
Item	Shoaling / Sedimentation
Down stream at Oak Avenue.	
cathom_20090908_38.jpg

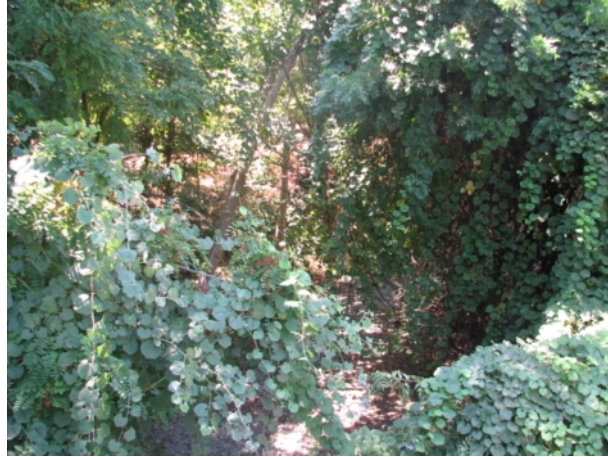
Levee Mile Report Line	78
Start Levee Mile	0.00
End Levee Mile	0.00
Location	
Category	Channels
Item	Erosion / Bank Caving
Down stream at Oak Avenue.	
cathom_20090908_39.jpg

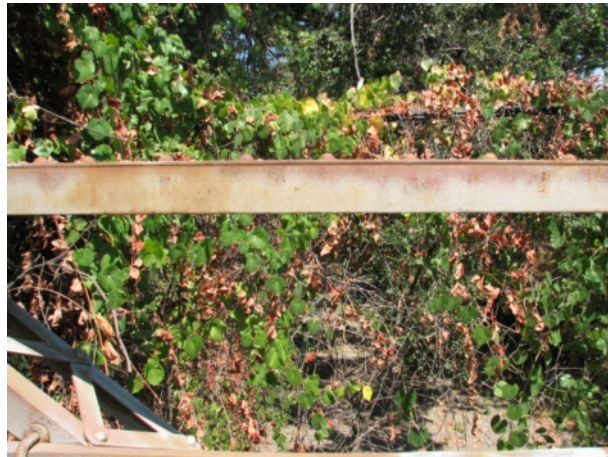
Levee Mile Report Line	81
Start Levee Mile	0.00
End Levee Mile	0.00
Location	
Category	Channels
Item	Vegetation & Obstructions
Up stream at Grape Way.	
cathom_20090908_40.jpg

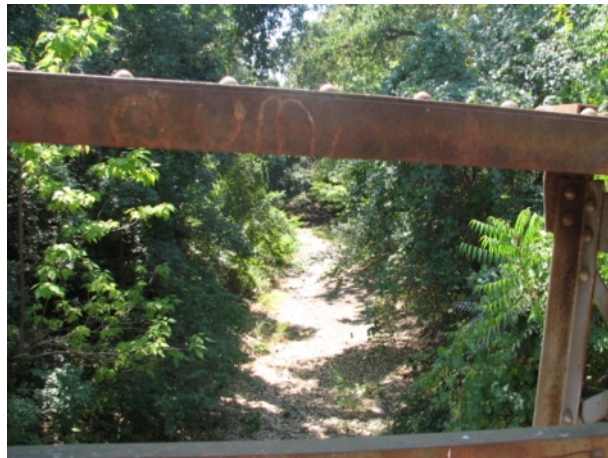
Levee Mile Report Line	86
Start Levee Mile	0.00
End Levee Mile	0.00
Location	
Category	Channels
Item	Vegetation & Obstructions
Down stream from Grape Way.	
cathom_20090908_41.jpg

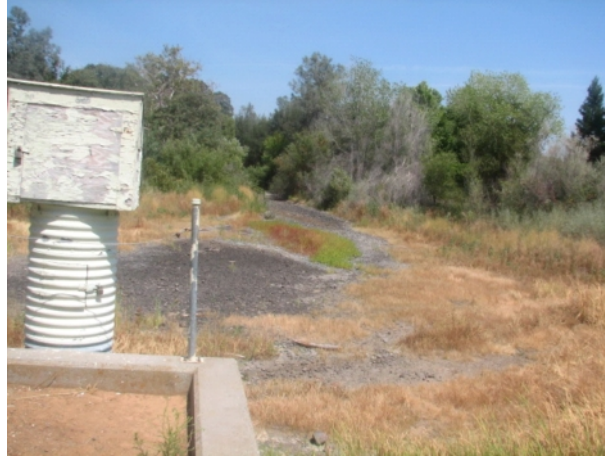
Levee Mile Report Line	1
Start Levee Mile	0.00
End Levee Mile	0.00
Location	
Category	Channels
Item	Vegetation & Obstructions
Up stream from Little Chico Ck Control structure.	
cathom_20090909_42.jpg

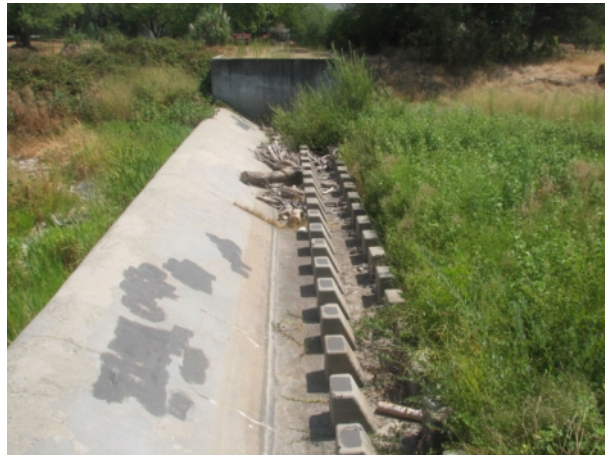
Levee Mile Report Line	1
Start Levee Mile	0.00
End Levee Mile	0.00
Location	
Category	Channels
Item	Vegetation & Obstructions
Little Chico Ck Control structure.	
cathom_20090909_43.jpg

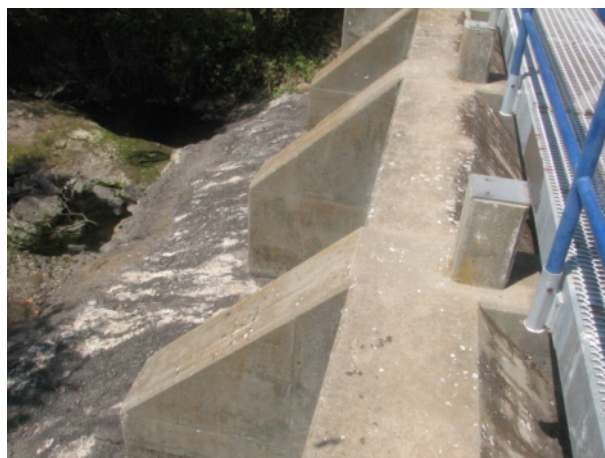
Levee Mile Report Line	1
Start Levee Mile	0.00
End Levee Mile	0.00
Location	
Category	Channels
Item	Vegetation & Obstructions
Little Chico Ck Control structure.	
cathom_20090909_44.jpg

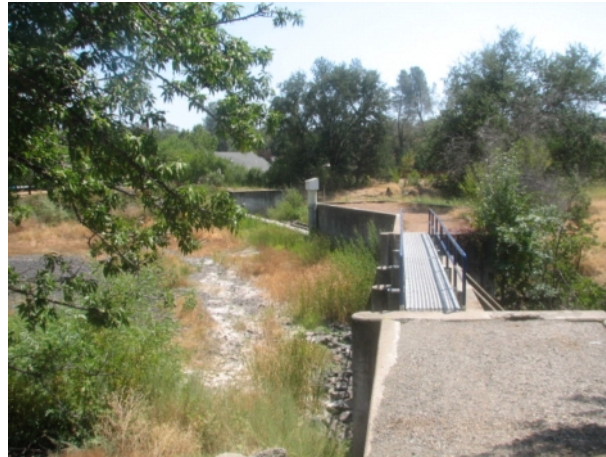
Levee Mile Report Line	1
Start Levee Mile	0.00
End Levee Mile	0.00
Location	
Category	Channels
Item	Vegetation & Obstructions
Little Chico Ck Control structure.	
cathom_20090909_45.jpg

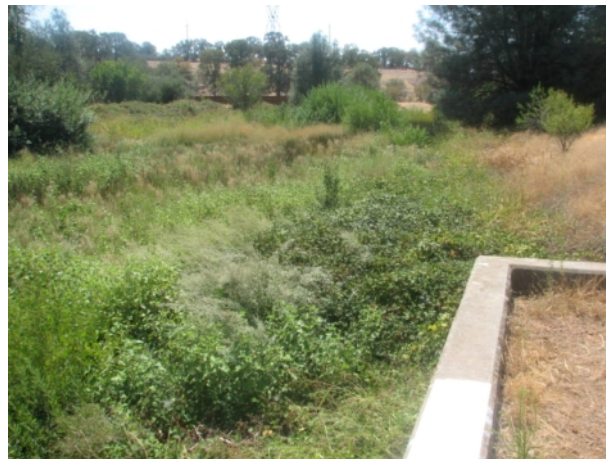
Levee Mile Report Line	6
Start Levee Mile	0.00
End Levee Mile	0.00
Location	
Category	Channels
Item	Vegetation & Obstructions
Down stream from Little Chico Ck structure.	
cathom_20090909_46.jpg

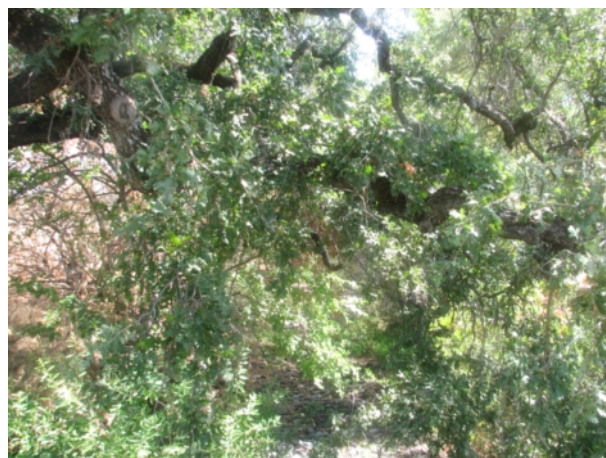
Levee Mile Report Line	11
Start Levee Mile	0.00
End Levee Mile	0.00
Location	
Category	Channels
Item	Vegetation & Obstructions
Up stream from Bruce Road, vegetation over hanging the channel.	
cathom_20090909_47.jpg

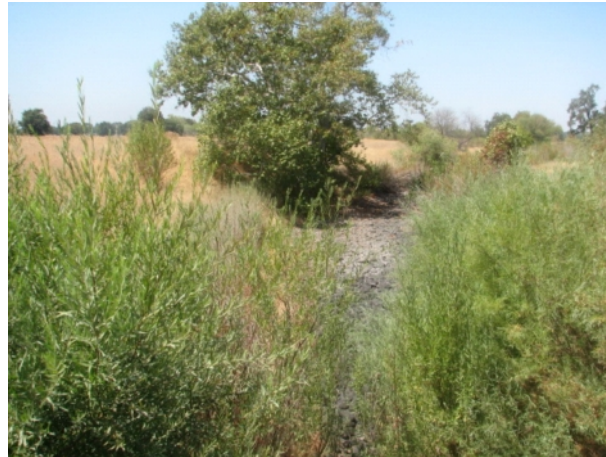
Levee Mile Report Line	16
Start Levee Mile	0.00
End Levee Mile	0.00
Location	
Category	Channels
Item	Vegetation & Obstructions
Up stream from Bruce Road.	
cathom_20090909_48.jpg

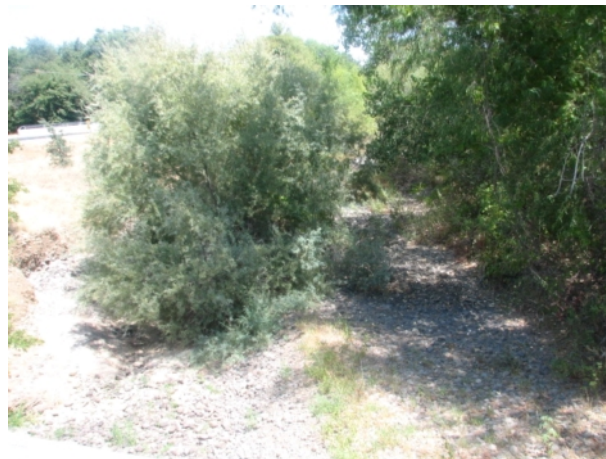
Levee Mile Report Line	21
Start Levee Mile	0.00
End Levee Mile	0.00
Location	
Category	Channels
Item	Vegetation & Obstructions
Up stream from Forrest Avenue.	
cathom_20090909_49.jpg

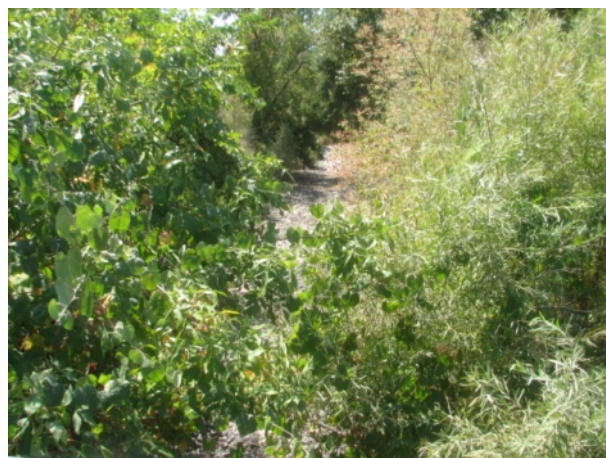
Levee Mile Report Line	26
Start Levee Mile	0.00
End Levee Mile	0.00
Location	
Category	Channels
Item	Vegetation & Obstructions
Down stream from Forrest Avenue, vegetation on the channel slopes.	
cathom_20090909_50.jpg

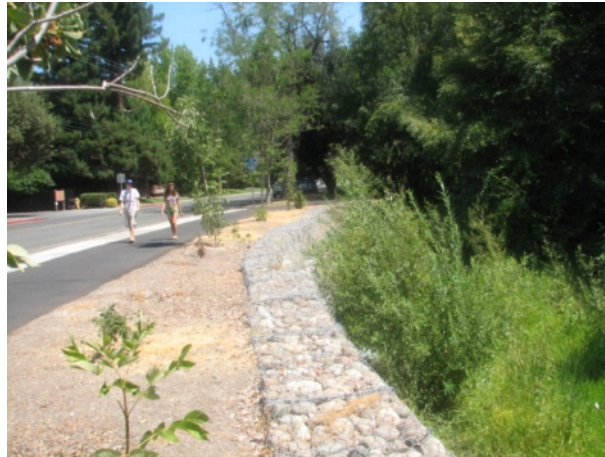
Levee Mile Report Line	31
Start Levee Mile	0.00
End Levee Mile	0.00
Location	
Category	Channels
Item	Vegetation & Obstructions
Erosion repair site, up stream from Highway 99, looking up stream.	
cathom_20090909_51.jpg

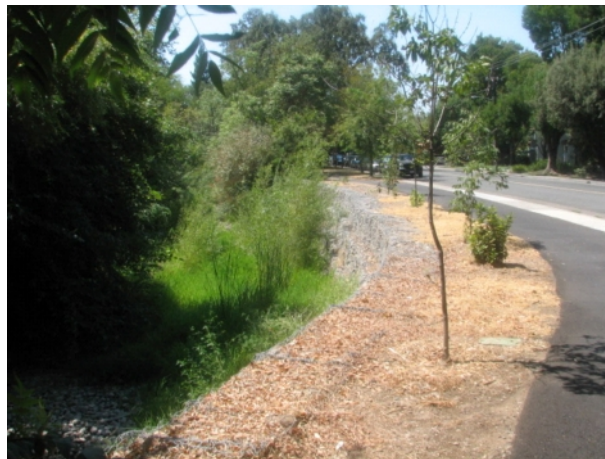
Levee Mile Report Line	36
Start Levee Mile	0.00
End Levee Mile	0.00
Location	
Category	Channels
Item	Vegetation & Obstructions
Erosion repair site, up stream of Highway 99. Looking down stream.	
cathom_20090909_52.jpg

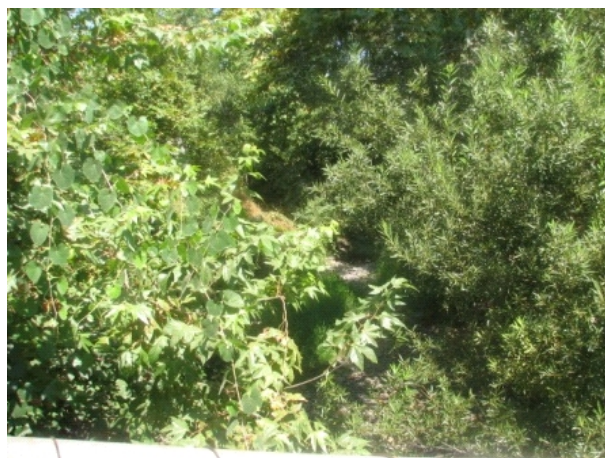
Levee Mile Report Line	41
Start Levee Mile	0.00
End Levee Mile	0.00
Location	
Category	Channels
Item	Vegetation & Obstructions
Up stream of Boucher Street, dense growth on both banks.	
cathom_20090909_53.jpg

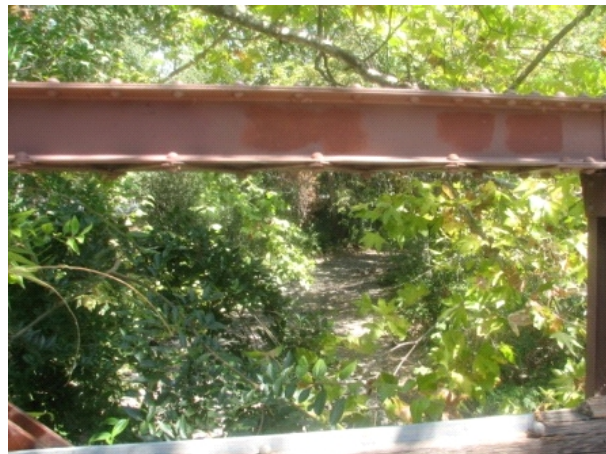
Levee Mile Report Line	51
Start Levee Mile	0.00
End Levee Mile	0.00
Location	
Category	Channels
Item	Vegetation & Obstructions
Up stream from Olive Street, dense growth on both banks.	
cathom_20090909_55.jpg

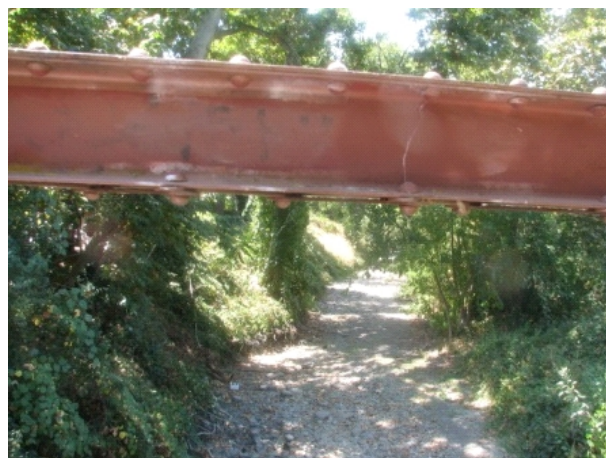
Levee Mile Report Line	56
Start Levee Mile	0.00
End Levee Mile	0.00
Location	
Category	Channels
Item	Vegetation & Obstructions
Down stream of Olive Street, dense growth on both banks.	
cathom_20090909_56.jpg

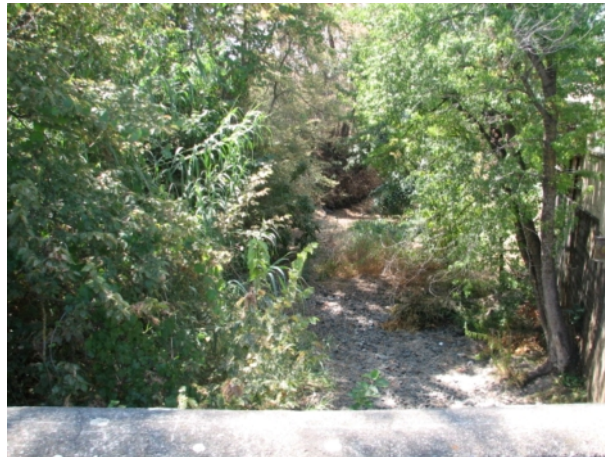
Levee Mile Report Line	66
Start Levee Mile	0.00
End Levee Mile	0.00
Location	
Category	Channels
Item	Vegetation & Obstructions
Down stream from Broadway Street, dense growth on both banks.	
cathom_20090909_58.jpg

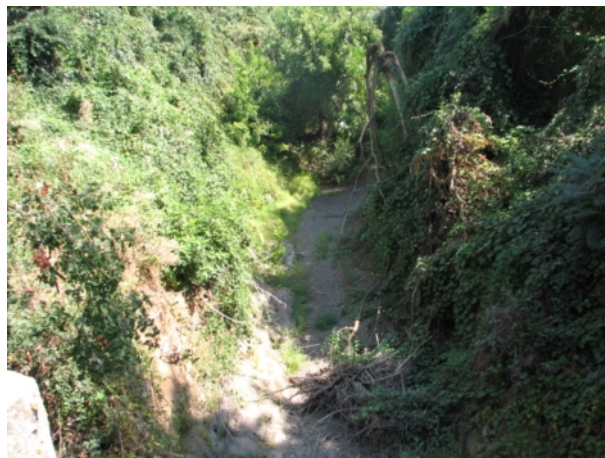
Levee Mile Report Line	71
Start Levee Mile	0.00
End Levee Mile	0.00
Location	
Category	Channels
Item	Vegetation & Obstructions
Up stream from Lone Pine Street, dense growth on both banks.	
cathom_20090909_59.jpg
